REPORT BMS89

Structural Properties of  
"Precision-Built, Jr." (Second  
Construction) Prefabricated  
Wood-Frame Wall Construction  
Sponsored by the Homasote Co.

Forest Products Laboratory, Forest Service, United States Department of Agriculture

ISSUED JULY 17, 1942

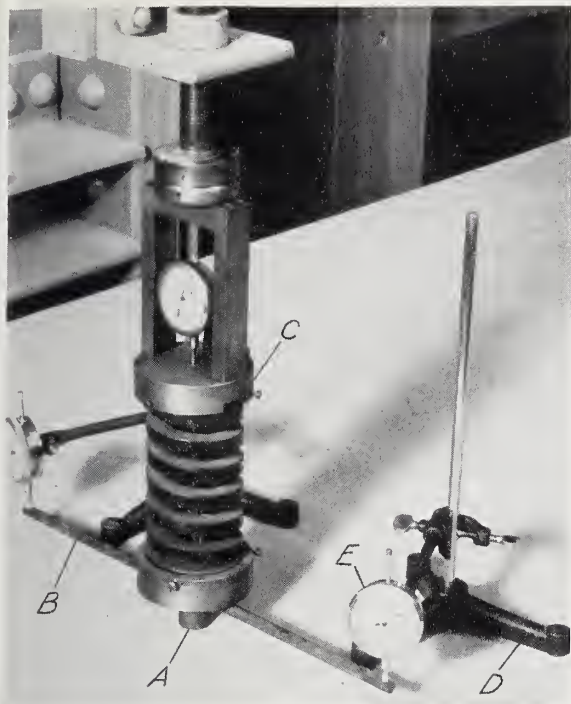
FIGURE 1.—Apparatus for concentrated-load test.

A, steel disk; B, cross bar; C, dynamometer; D, stand; E, dial micrometer.

The indentation under concentrated load and the set after the load was removed were measured, not the set only, as described in BMS2. The apparatus is shown in figure 1.

The load was applied to a steel disk, *A*, to which the crossbar, *B*, was rigidly attached, and was measured by means of the dynamometer, *C*. Two stands, *D*, rested on the face of the specimen, one over each inner stud. Each stand supported a dial micrometer, *E*, the spindle of which was in contact with the crossbar 8 in. from the disk. The micrometers were graduated to 0.001 in., and readings were recorded to the nearest division. The initial reading (average of the micrometer readings) was observed under the initial load, which included the weight of the disk and dynamometer. A load was applied to the disk, and the average of the micrometer readings

minus the initial reading was taken as the depth of the indentation under load.

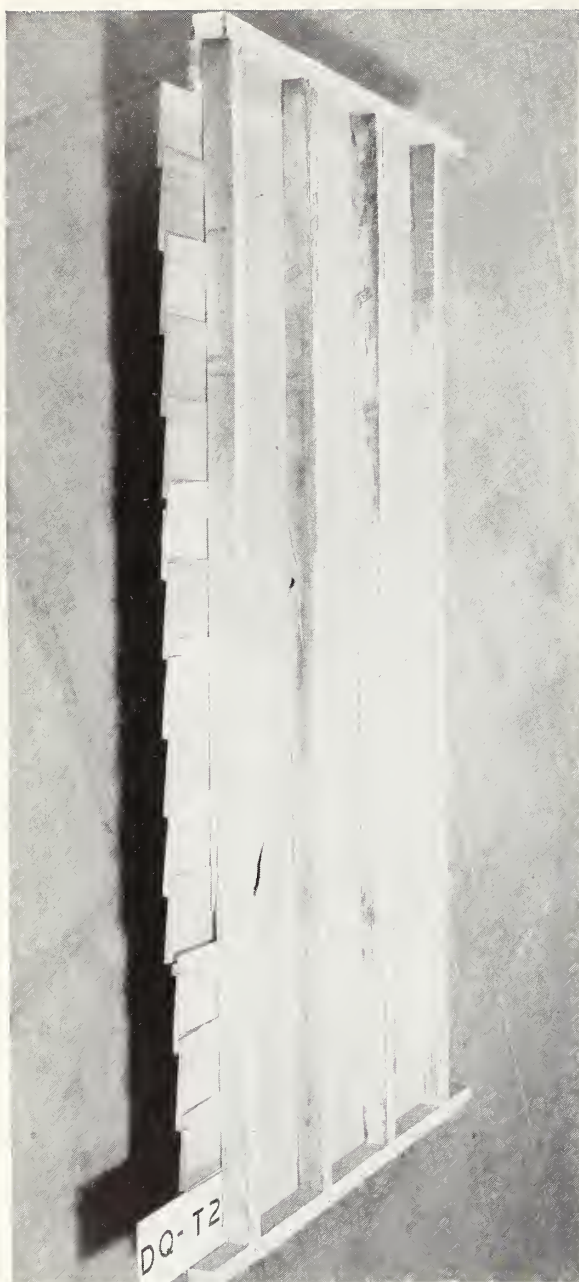
FIGURE 2.—Wall DQ.

Typical 4-foot specimen.

After each specimen was tested, the fiberboard face was removed to expose the framing and a sample of the bevel siding, spacer block, and framing was taken for identification of the species and for determination of the moisture content. Photographs were made of each specimen showing the failures and the character of the wood in the framing. Typical specimens are shown in figures 2 and 3.

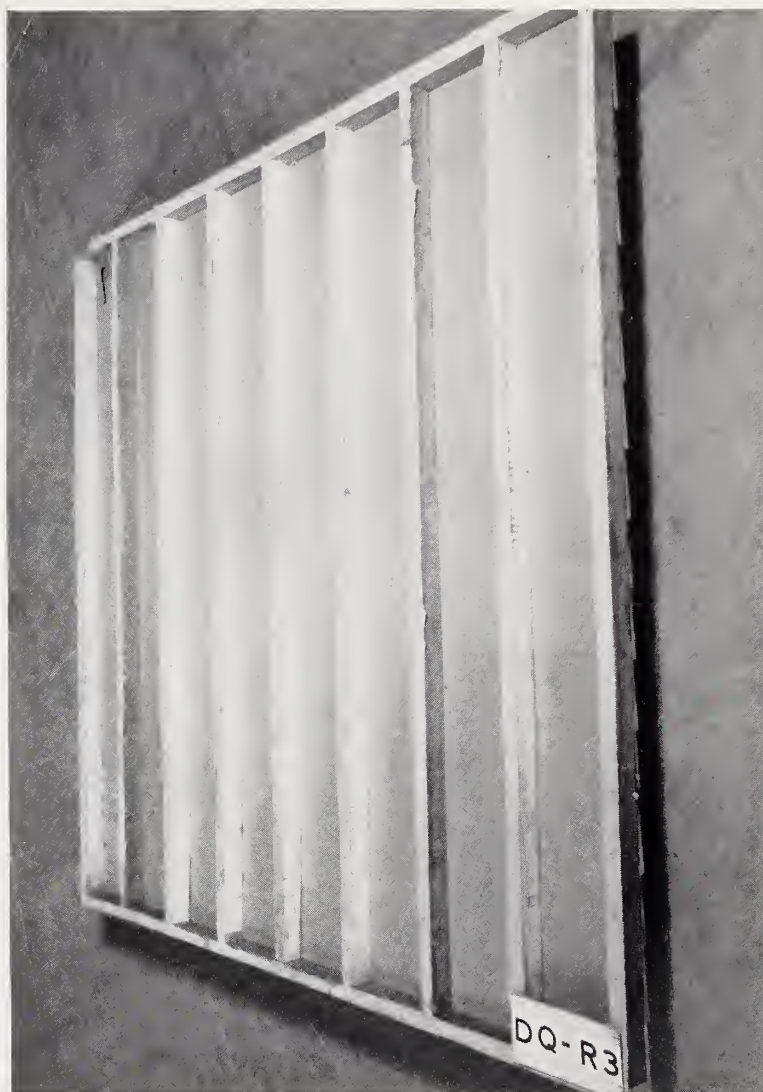
FIGURE 3.—*Wall DQ*.  
Typical 8-foot specimen.

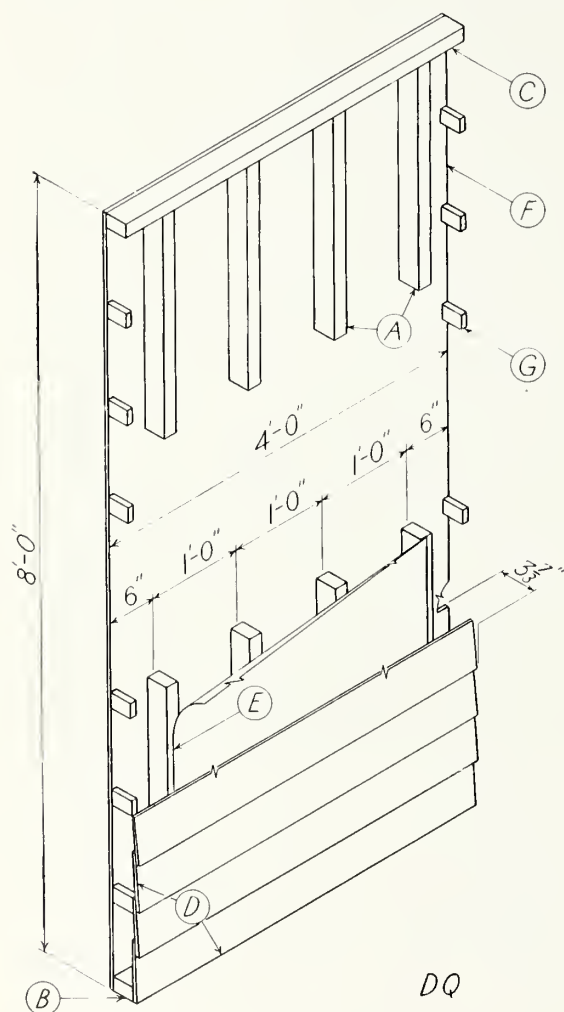
FIGURE 4.—Four-foot specimen DQ.

A, studs; B, floor plate; C, top plate; D, bevel siding; E, sheathing paper; F, inside face; G, spacer blocks.

The 4-ft specimens, shown in figure 4, were

8 ft 0 in. high, 4 ft 0 in. wide, and 3 3/8 in. thick. Each was a wood frame to which faces

were fastened. The frame consisted of four studs, A, fastened to a floor plate, B, and a top plate C. The outside face was bevel siding, D, over sheathing paper, E. The inside face was one sheet of insulating fiberboard, F. The edges of the faces were connected by wood spacer blocks G.

*Floor plate and top plate.*—Both floor plate, B, and top plate, C, were Douglas fir, 1 1/2 by 2 5/8 in. (nominal 2 by 3 in.), 4 ft. 0 in. long.

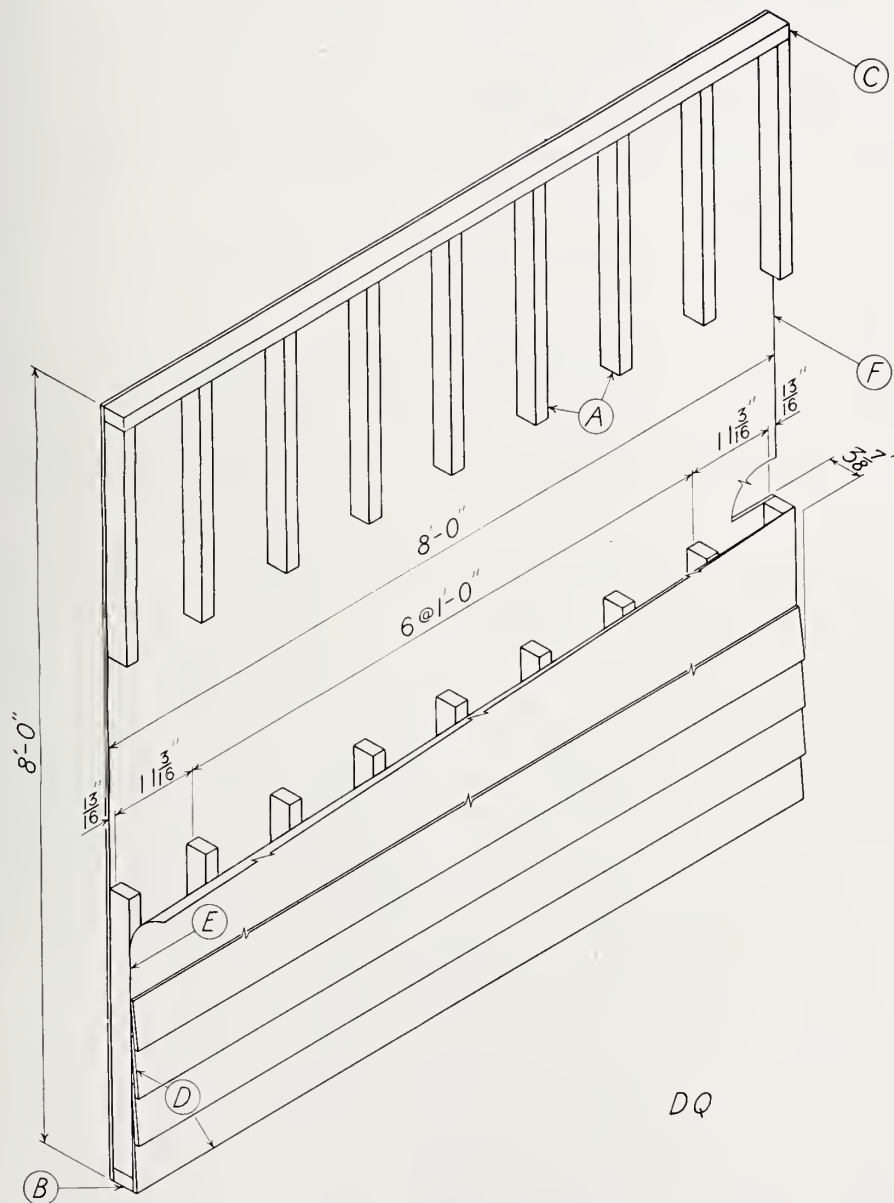
FIGURE 5.—Eight-foot specimen *DQ*.

A, studs; B, floor plate; C, top plate; D, bevel siding; E, sheathing paper; F, inside face.

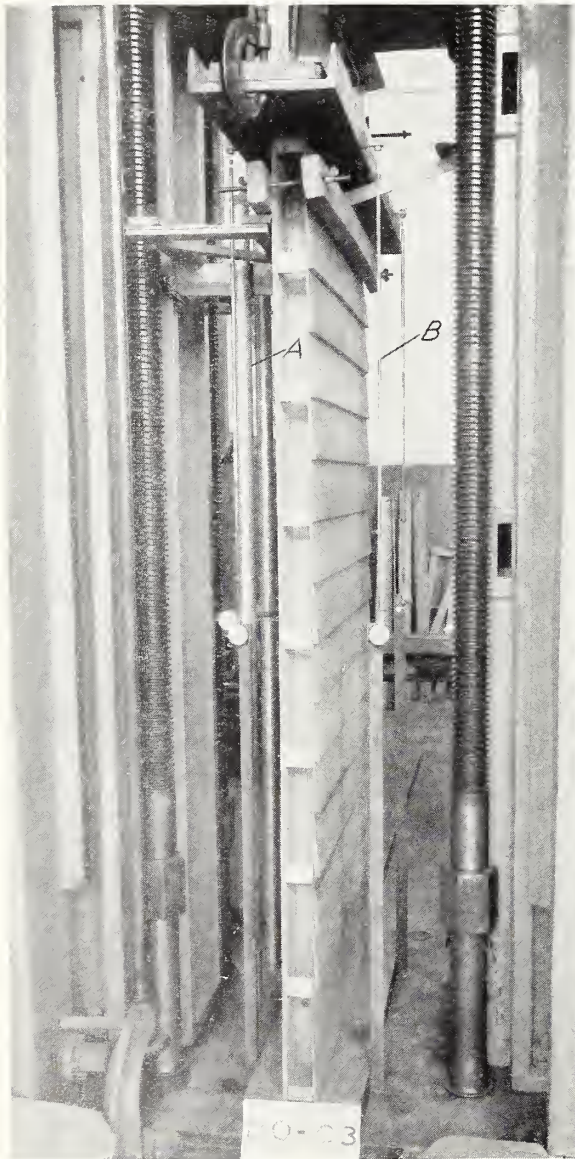
FIGURE 6.—Wall specimen DQ-C3 under compressive load.

A, deflectometer; B, compressometer.

Specimen *DQ-C3* under compressive load is shown in figure 6. The results for specimens *DQ-C1*, and *C2*, and *C3* are shown in table 5 and figures 7 and 8.

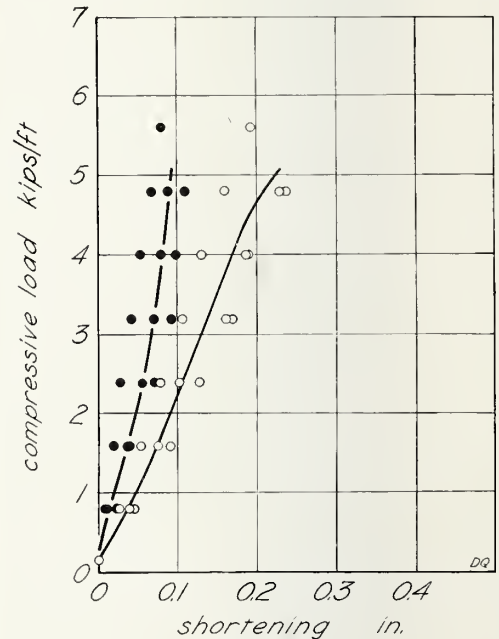
FIGURE 7.—Compressive load on wall DQ.

Load-shortening (open circles) and load-set (solid circles) results for specimens DQ-C1, C2, and C3. The load was applied 0.88 in. (one-third the thickness of the frame) from the inside surface of the studs. The loads are in kips per foot of actual width of specimen.

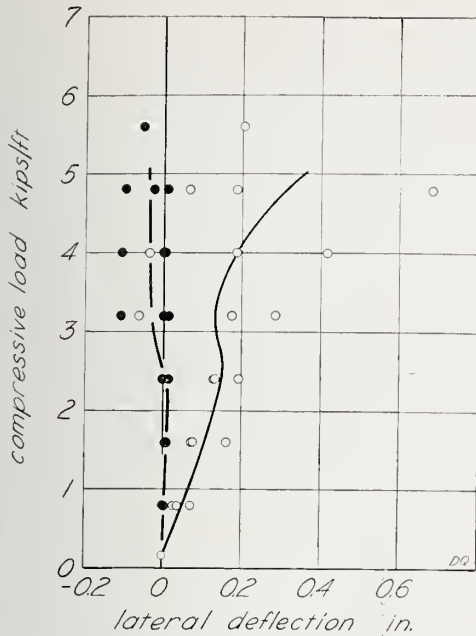
FIGURE 8.—Compressive load on wall *DQ*.

Load-lateral deflection (open circles) and load-lateral set (solid circles) results for specimens *DQ-C1*, *C2*, and *C3*. The load was applied 0.88 in. (one-third the thickness of the frame) from the inside face of the studs. The loads are in kips per foot of actual width of specimen. The deflections and sets are for a gage length of 7 ft. 6 in., the gage length of the deflectometers.

studs at the outside edge. Under maximum load on each specimen, the studs continued to bend laterally toward the outside face (the face farther from the load line).

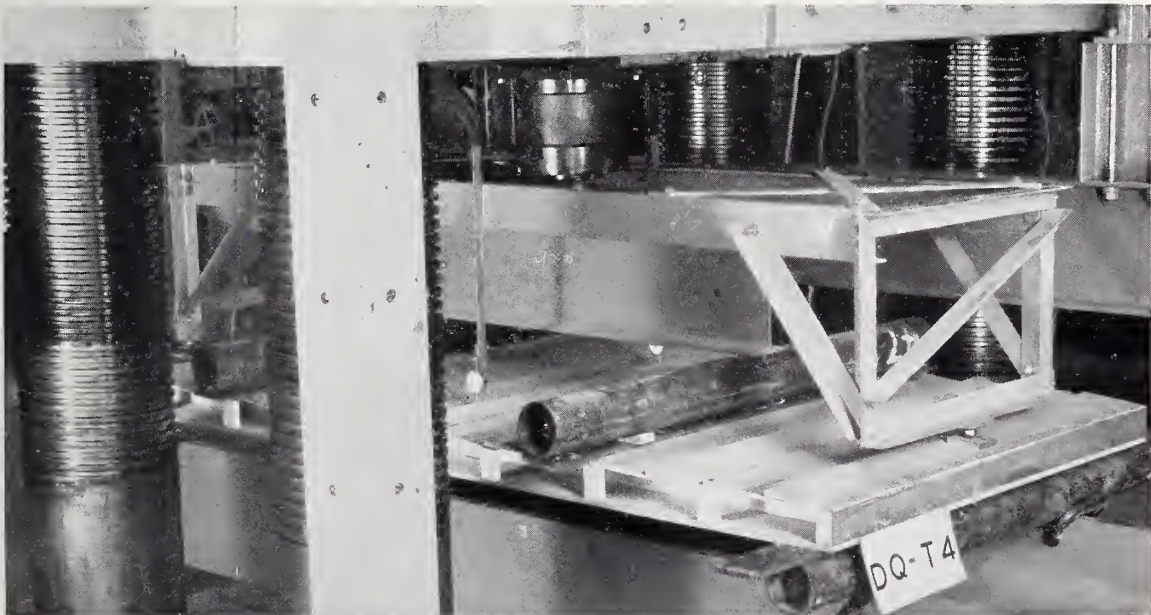
FIGURE 9.—Wall specimen *DQ-T4* under transverse load.

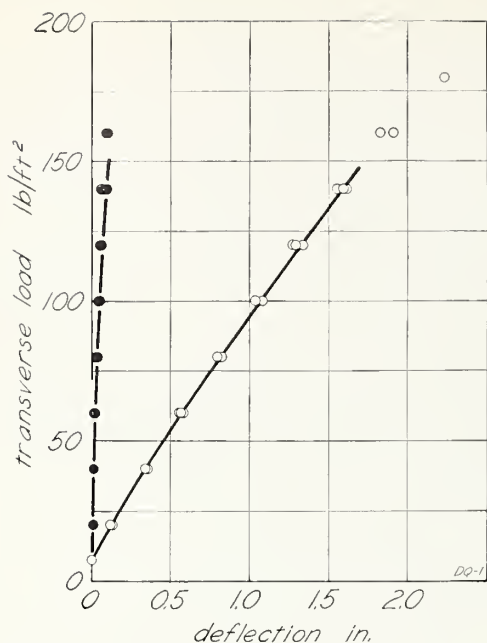
FIGURE 10.—Transverse load on wall DQ, load applied to inside face.

Load-deflection (open circles) and load-set (solid circles) results for specimens DQ-T1, T2, and T3 on the span 7 ft. 6 in. The load (pounds per square foot) is the total load divided by the product of the span and the width of the specimen.

Under a load of 153 lb/ft<sup>2</sup>, one outer stud in specimen *T1* ruptured under a loading roller. In specimen *T3* at a load of 175 lb/ft<sup>2</sup>, an outer stud ruptured at a knot near a loading roller, and under a load of 187 lb/ft<sup>2</sup>, the other outer stud ruptured at midspan.

Under the maximum load, both outer studs and one inner stud ruptured in specimens *T1* and *T3*. In specimen *T2* one outer stud and the adjacent inner stud ruptured under the maximum load.

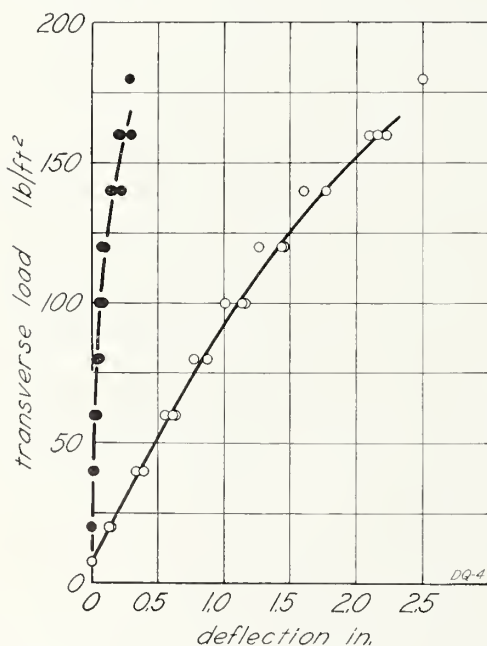
FIGURE 11.—Transverse load on wall DQ, load applied to outside face.

Load-deflection (open circles) and load-set (solid circles) results for specimens DQ-T4, T5, and T6 on the span 7 ft. 6 in. The load (pounds per square foot) is the total load divided by the product of the span and the width of the specimen.

Under a load of 170 lb/ft<sup>2</sup>, an outer stud of specimen *T5* cracked longitudinally between two knots under a loading roller.

Under the maximum load, one inner stud ruptured in specimens *T4* and *T6*, and in specimen *T5* both outer studs and one inner stud ruptured. The ruptured inner stud in specimen *T4* caused the insulating fiberboard to separate

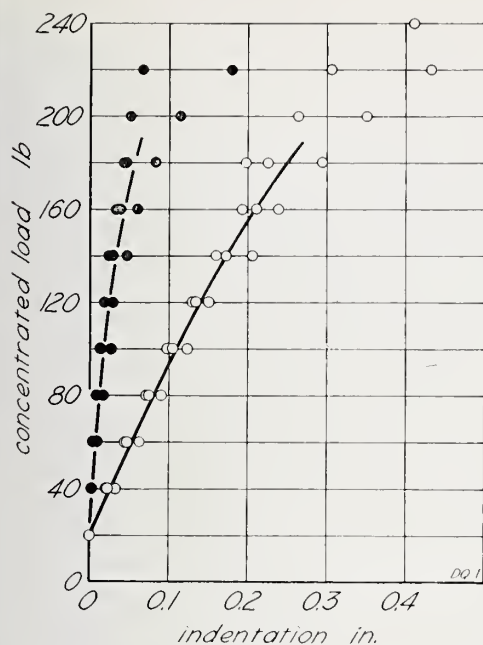
FIGURE 12.—Concentrated load on wall DQ, load applied to inside face.

Load-indentation (open circles) and load-set (solid circles) results for specimens DQ-P1, P2, and P3.

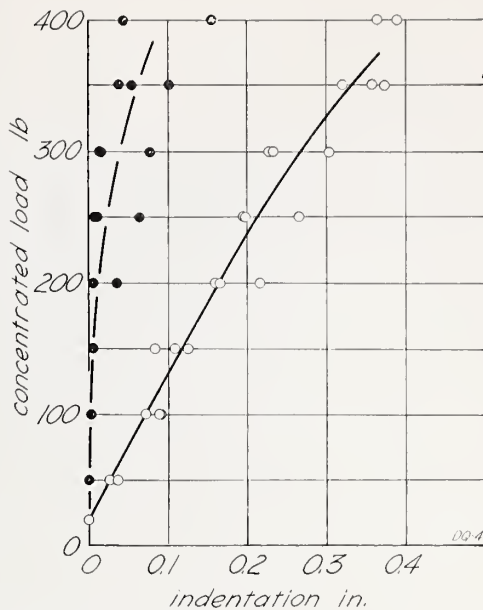
FIGURE 13.—Concentrated load on wall DQ, load applied to outside face.

Load-indentation (open circles) and load-set (solid circles) results for specimens DQ-P4, P5, and P6.

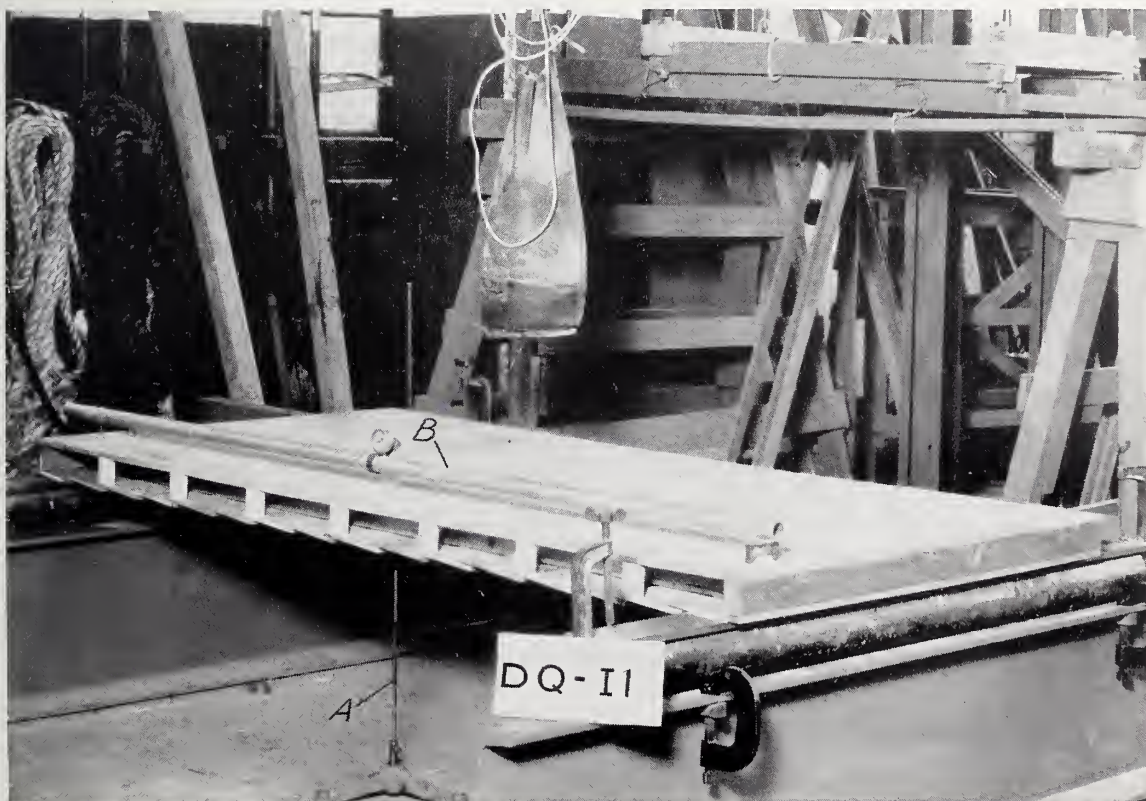
FIGURE 14.—Wall specimen DQ-II during the impact test.

A, deflectometer; B, set gage.

The deflections and sets under the impact load were measured by means of two deflectometers and two set gages, not one of each as described in BMS2. The deflectometers were placed in contact with the unloaded face of the specimen at midspan, one under each outer stud, and the set gages rested on the loaded face, one over each outer stud. The readings, therefore, were not affected by local deformations of the faces.

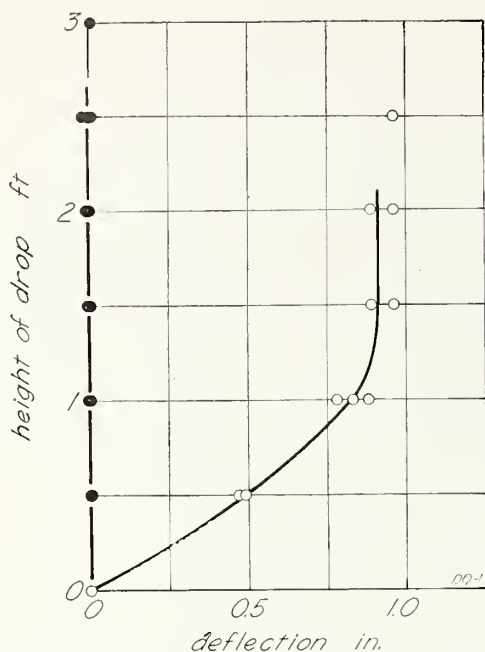
FIGURE 15.—Impact load on wall DQ, load applied to inside face.

Height of drop-deflection (open circles) and height of drop-set (solid circles) results for specimens DQ-11, 12, and 13 on the span 7 ft 6 in.

In specimens I1, I2, and I3 the fiberboard fractured under the sandbag at a drop of 1.5 ft, and at a drop of 2.0 ft. the sandbag broke through the fiberboard. At the maximum drop the bevel siding on specimens I1, I2, and I3 ruptured.

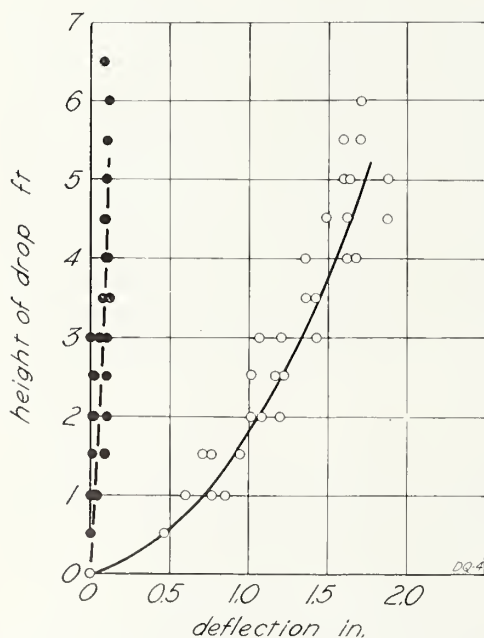
FIGURE 16.—Impact load on wall DQ, load applied to outside face.

Height of drop-deflection (open circles) and height of drop-set (solid circles) results for specimens DQ-14, 15, and 16 on the span 7 ft 6 in.

At a drop of 3.0 ft, 4.5 ft., and 2.0 ft for specimens I4, I5, and I6 respectively, the fiberboard separated from the outer studs at mid-span. The bevel siding ruptured under the sandbag on specimens I4 and I6 at a drop of 4.5 ft and on specimen I5 at a drop of 4.0 ft. At the maximum drop for specimens, I4, I5, and I6, the fiberboard ruptured under the sandbag.

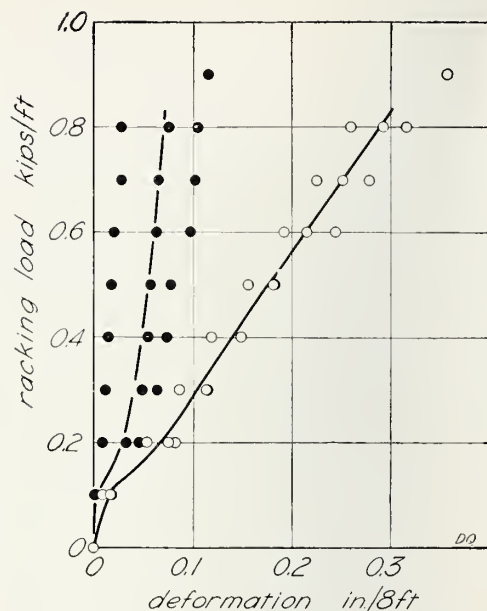
FIGURE 18.—Racking load on wall DQ.

Load-deformation (open circles) and load-set (solid circles) results for specimens DQ-R1, R2, and R3. The loads are in kips per foot of actual width of specimen.

Specimen DQ-R1 under racking load is shown in figure 17. The results on specimens DQ-R1, R2, and R3 are given in table 5 and in figure 18.

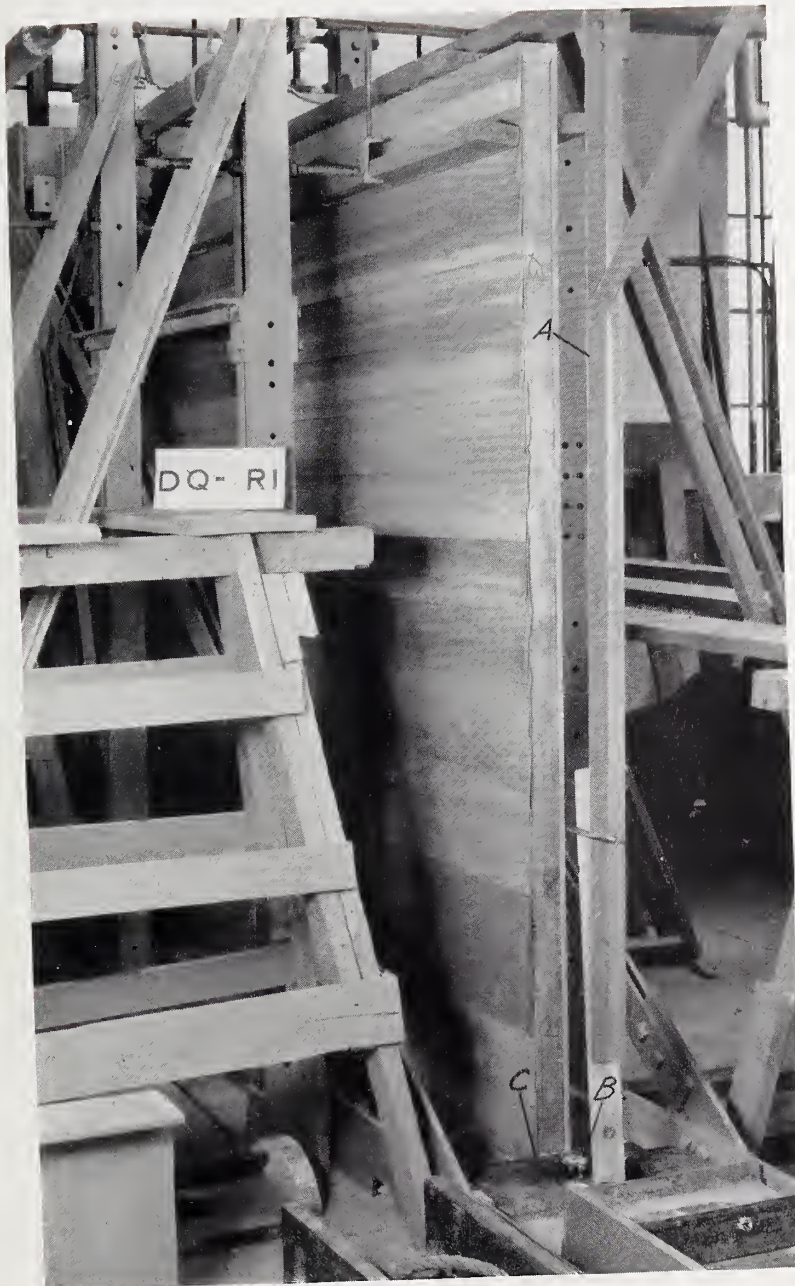
FIGURE 17.—Wall specimen DQ-R1 under racking load.  
A, deformer; B, dial micrometer; C, stop.

The deformations under racking load were measured with a right-angle deformeter, consisting of a steel channel and a steel angle braced to form a rigid connection. The channel rested on two steel plates,  $\frac{1}{2}$  in. thick and 4 in. square, on top of the specimen, with the steel angle extending downward in the plane of the specimen. Two pins passed snugly through the web of the channel into the top plate of the specimen. The floor plate was in contact with the stop, to which a dial micrometer was attached. The micrometer spindle was in contact with the steel angle of the deformeter. The gage length (distance from the top of the

specimen to the center of the spindle) was 7 ft. 10 in. The micrometer was graduated to 0.001 in., and readings were recorded to the nearest division. The deformeter was used instead of the taut-wire mirror-scale device described in BMS2.

The racking loads were applied to the top plate, and the stop was in contact with the floor

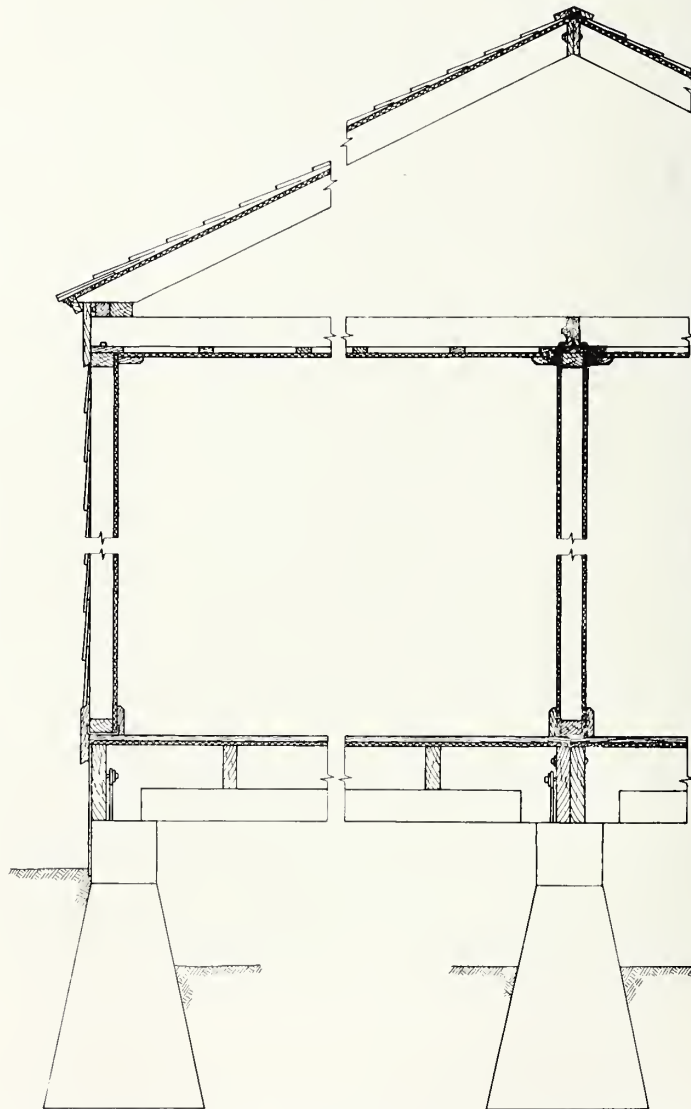
FIGURE 19.—Typical details of "Precision-Built, Jr." (second construction) house.

or roof sheathing as it was in previous constructions of this manufacturer. Typical details are shown in figure 19. Elements are fabricated in a shop near the building site, where jig tables facilitate assembly.

Wall sections are 7 ft 10 in. high and may be as long as 21 ft. The 2- by 3-in. studs are spaced 12 in. on centers in all exterior walls and load-bearing partitions and 16 in. on centers in other partitions. To these frames Homasote is fastened by glue and nails to form all interior surfaces. Building paper and wood bevel siding are applied to the exterior of all outside walls.

Ceiling sections consist of joists (2 by 4 in., 12 in. on centers) which are cross furred on the bottom with furring strips (1 by 2 in.), to

which Homasote is glued and nailed. Blanket insulation is installed between the ceiling joists directly on the furring strips.
